BUILDING INSPECTION REPORT

**40 Village Green Rd
Pittsfield, VT 05762**

Job #:18-40165.20

**Report Date:
January 2, 2019**

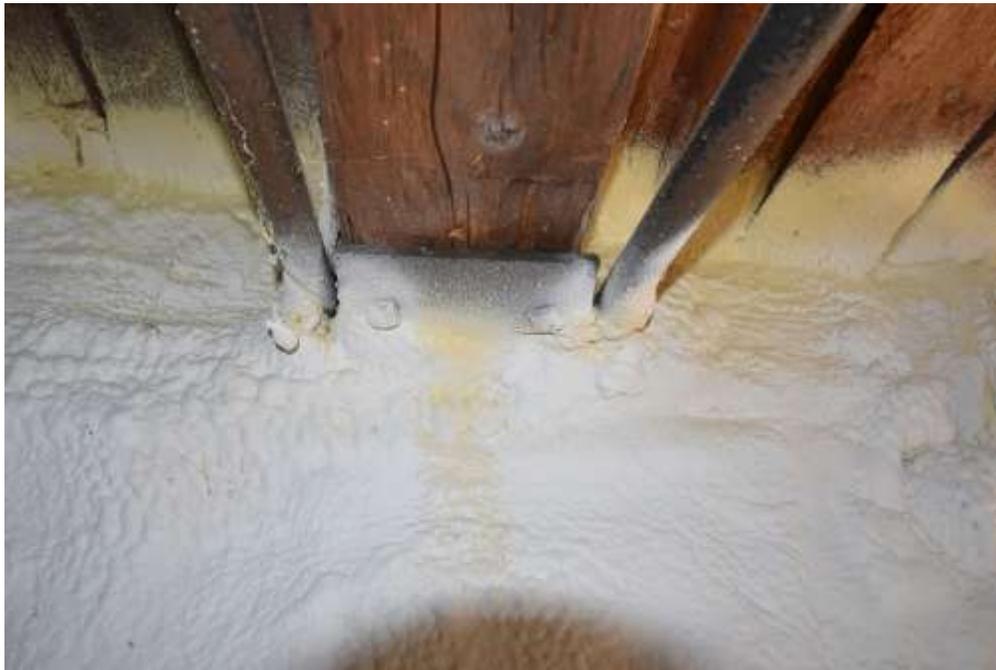
Figure 1, Floor Truss Tie Rod Connection

- Attic area remote from the access opening.
- Roof framing connections in the attic where insulated with spray foam and blown in cellulose insulation.
- Sills and sill pockets where insulated with spray foam insulation.
- Tie rod to beam connections where covered with spray foam insulation (see Figure 1).
- Foundation walls where finished off and insulated with spray foam insulation.

- The first floor should not be used for public assembly and group gatherings until the floor system is properly reinforced.
- The connection and bearing areas at the ends of the floor trusses should be exposed so that the configuration and condition can be determined.

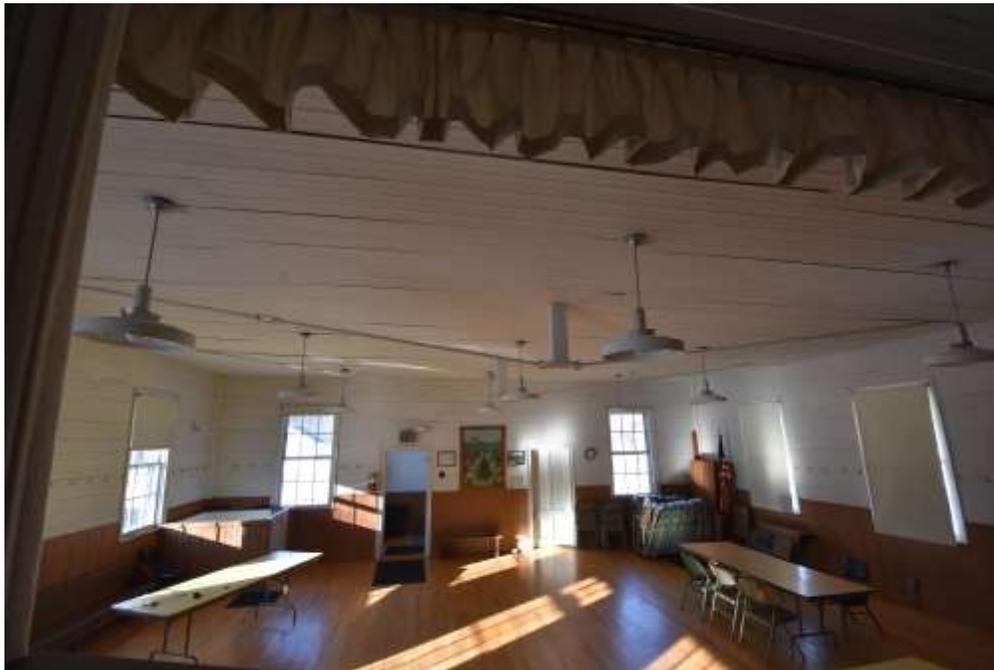
Figure 2, Visible Elements of Attic Floor Trusses

The timber posts that support the roof ridge beam are supported by timber and steel-rod attic truss members that span from sidewall to sidewall. A photo for the steel-rods and vertical elements for attic trusses are shown in Figure 2. The posts have notably separated from the ridge beam indicating that the

truss members have settled. The cause of this separation could not be determined from the evidence available.

The condition of the upper portions of the attic truss members and the associated structural connections are not visible due to the presence of cellulose and spray foam insulation. Furthermore, there is evidence that the roof has experienced some racking which is likely due to snow loading. Snow loads have likely increased in the years since the addition of the insulation, as snow is not melting as readily between storms. It was noted that the diagonal brace at the front of the building has pulled away from the ridge beam as shown in Figure 3.

- The integrity of roofing system structural members should be further investigated, and reinforcement made as necessary. In the interim, additional diagonal bracing of the roof system is recommended to prevent further racking of the roof under snow and wind loading.

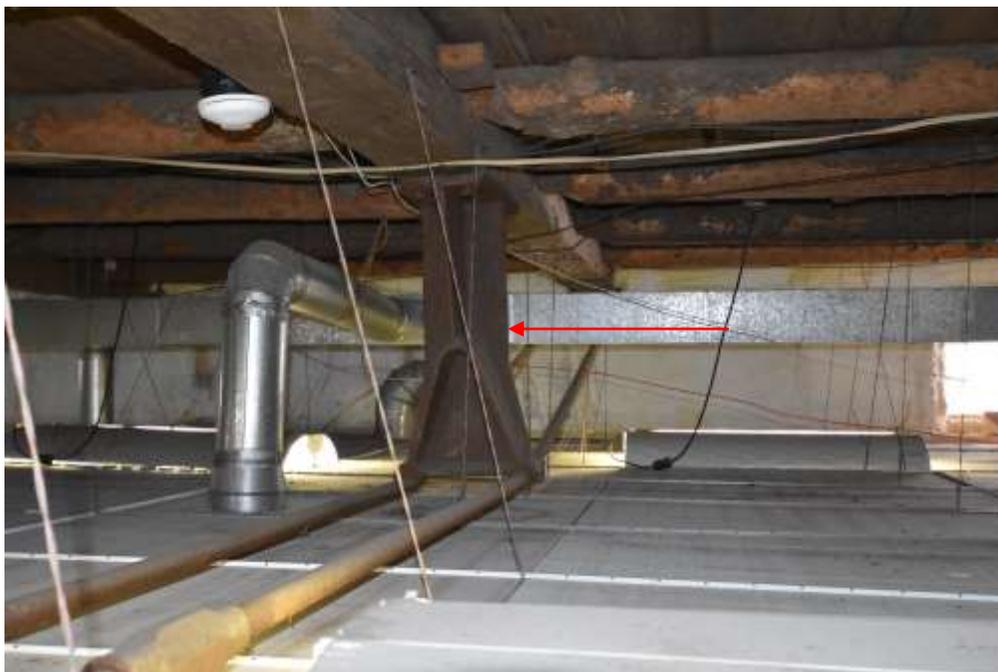
Figure 4, Truss post

The floor trusses consist of a pair of 1.5-inch diameter steel rods that make up the bottom chord and a 9 inch square timber top chord member. There are two heavy steel posts between the top and bottom chords located at approximately the third points of the 35-foot truss span (Figure 4). The trusses are spaced at approximately 9 foot 9 inches on center.

- We recommend reinforcing the existing 9 inch by 9 inch top chord members with laminated veneer lumber (LVL) beams. These beams would be through bolted to the sides of the existing beams, span the entire length of the truss, and would be supported at each end on the existing foundation walls, new columns or short bearing walls. Intermediate columns could be added in the basement area to reduce the size of the new LVL members.

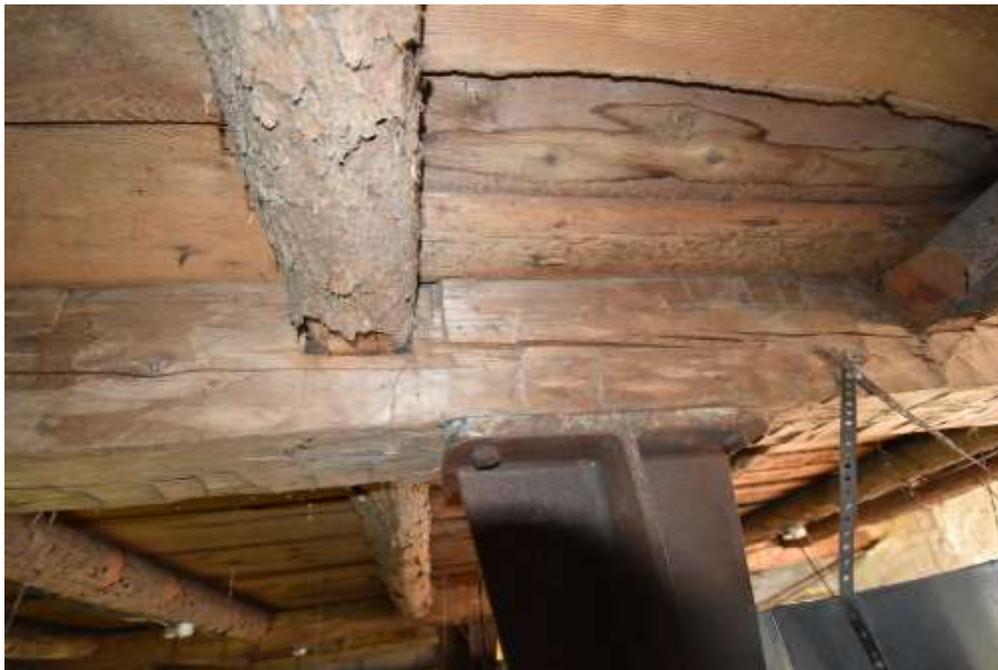
Figure 5, Splitting of Beam near Mortise and Tenons Joint above Truss Post

Log floor joists spaced at approximate 38 inch on center span between the floor trusses. The logs vary in diameter between 5 ½ inches and 7 inches and the species appear to be spruce. The logs are connected to the top chord truss beams with mortise and tenon joints. This joinery tends to weaken the timber beam where the mortise has been cut and reduces available cross section for shear load resistance at the tenon location at the ends of the floor joists. A photo of the weakened section and horizontal splitting at the mortise and tenon joint above one of the truss posts is shown in Figure 5.

- To facilitate installation of the new LVL members as well as simplify a floor joist upgrade, we recommend removing the existing log floor joists and replacing them with new 2x10 joists spaced at 16 inches on center.
